Bahamas Hurricane Dorian Response Shelter & Settlements

This case study presents the shelter-related interventions undertaken in the Bahamas in response to Hurricane Dorian 2019, and funded under the International Federation of the Red Cross and Red Crescent Societies (IFRC) and The Bahamas Red Cross Society² (BRCS) appeal MDRBS003. The BRCS and IFRC worked as one team to undertake the interventions described in this case study. Building on the experience and learning from the appeal funded shelter activities, BRCS also undertook further shelter interventions using many of the systems and processes described in this case study.

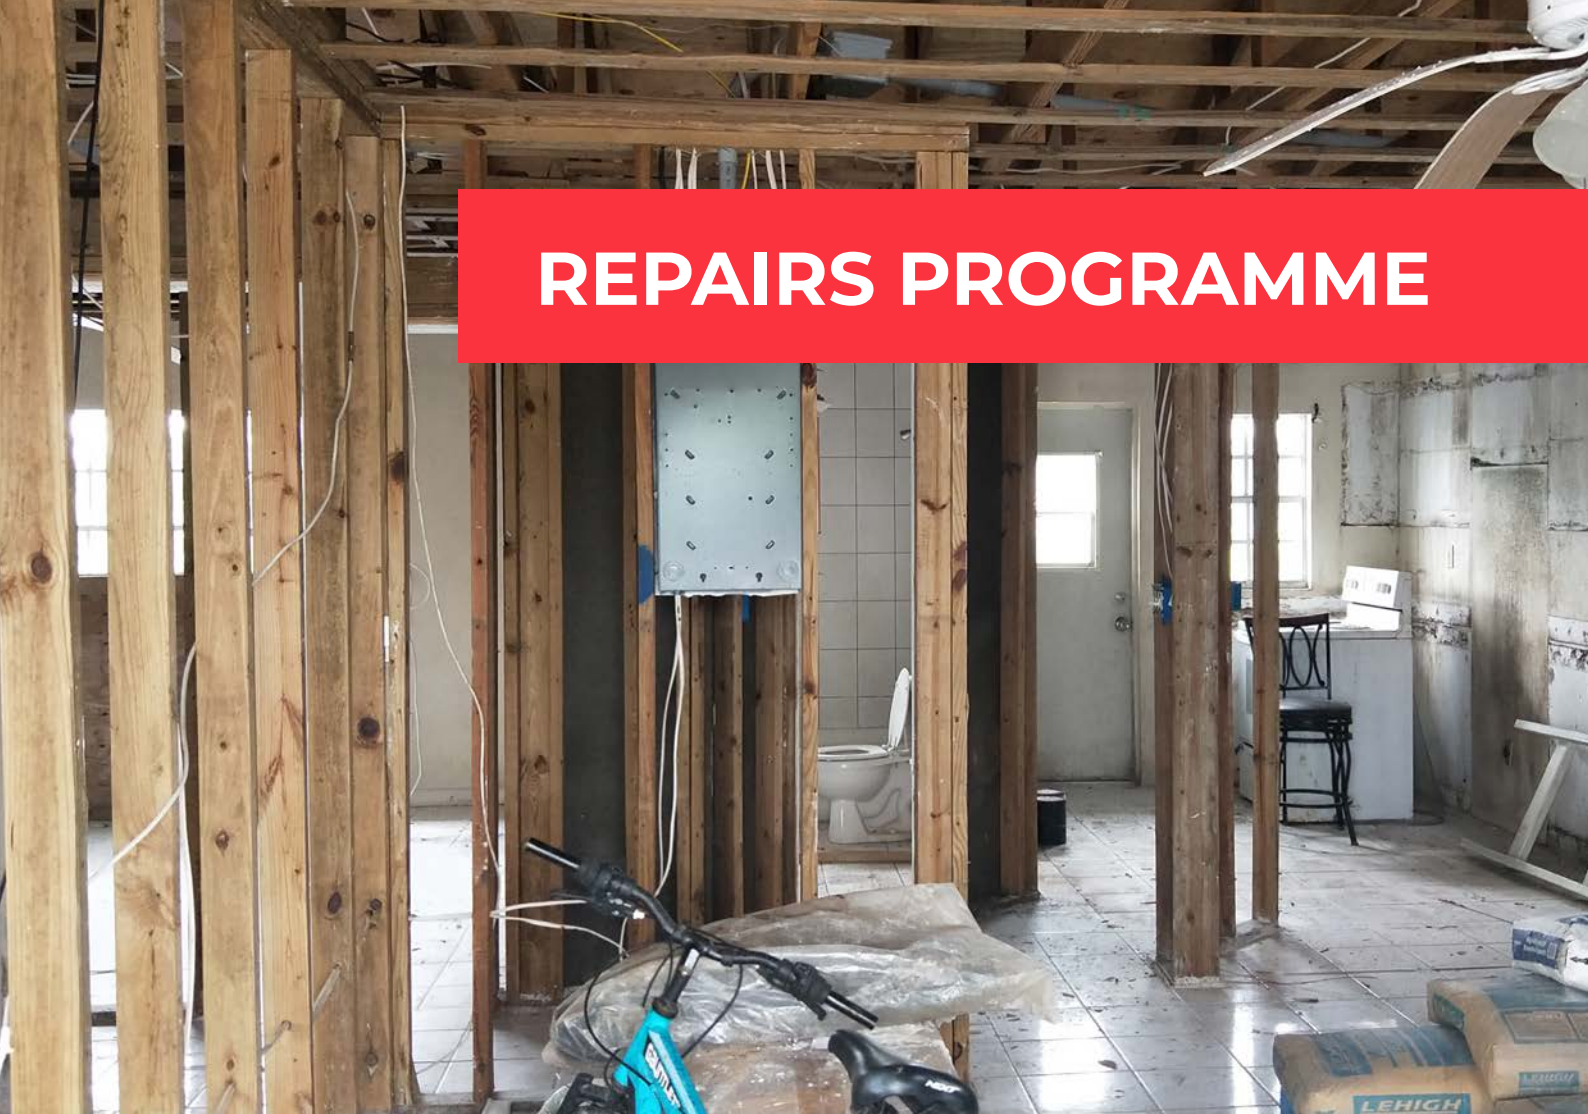
Internal home repairs being undertaken in Abaco, April 2020 Source: IFRC

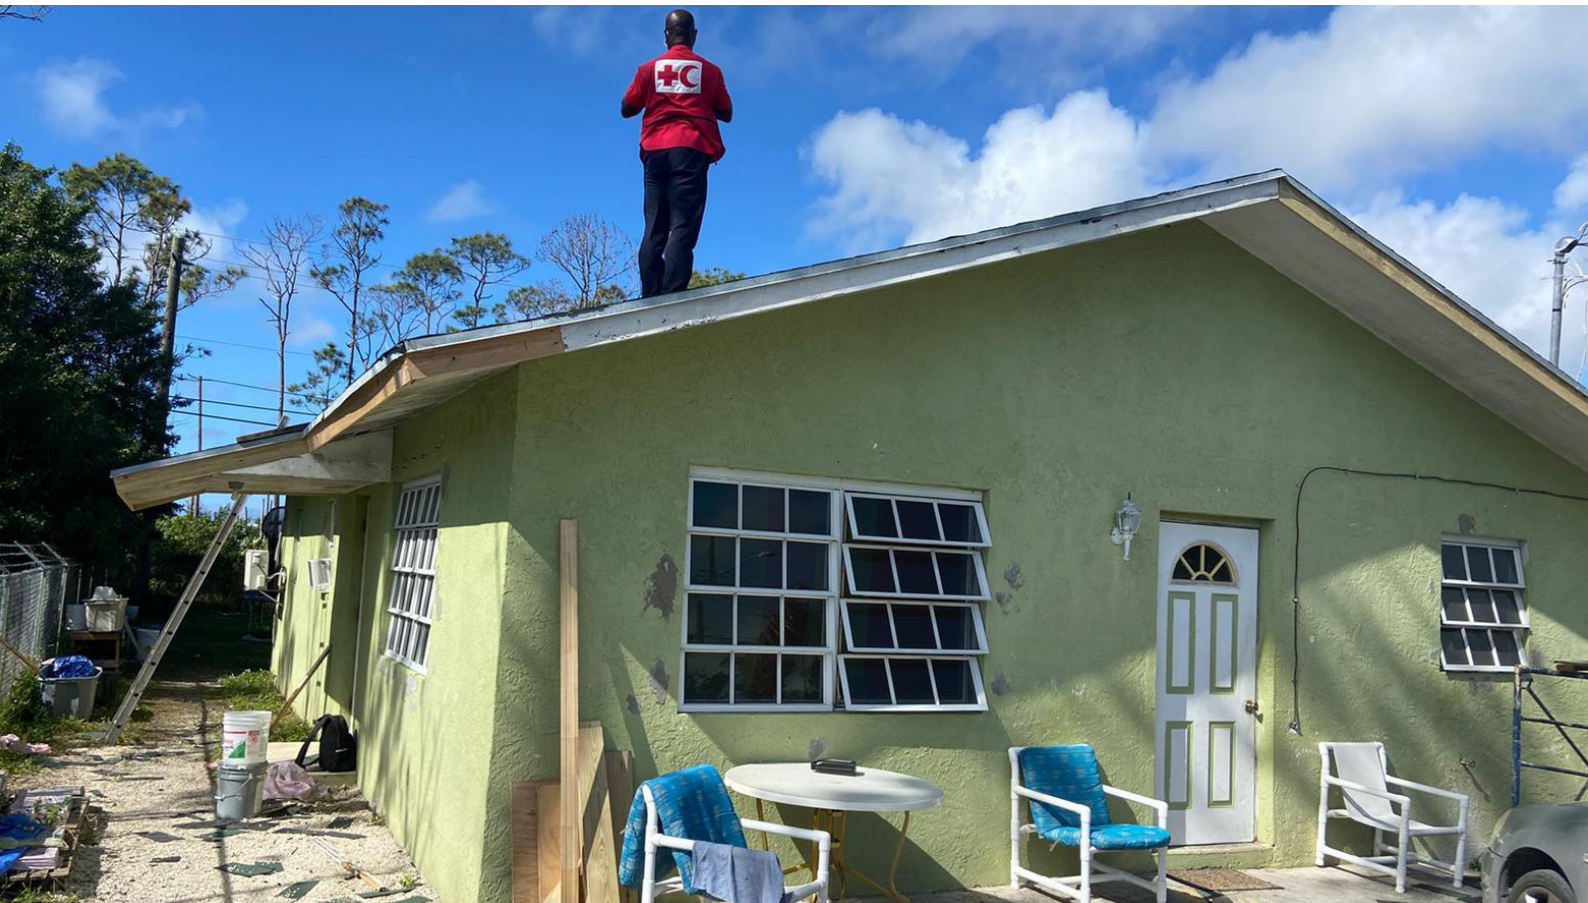
Roof assessment for repairs in Grand Bahama, May 2021 (Source: IFRC)

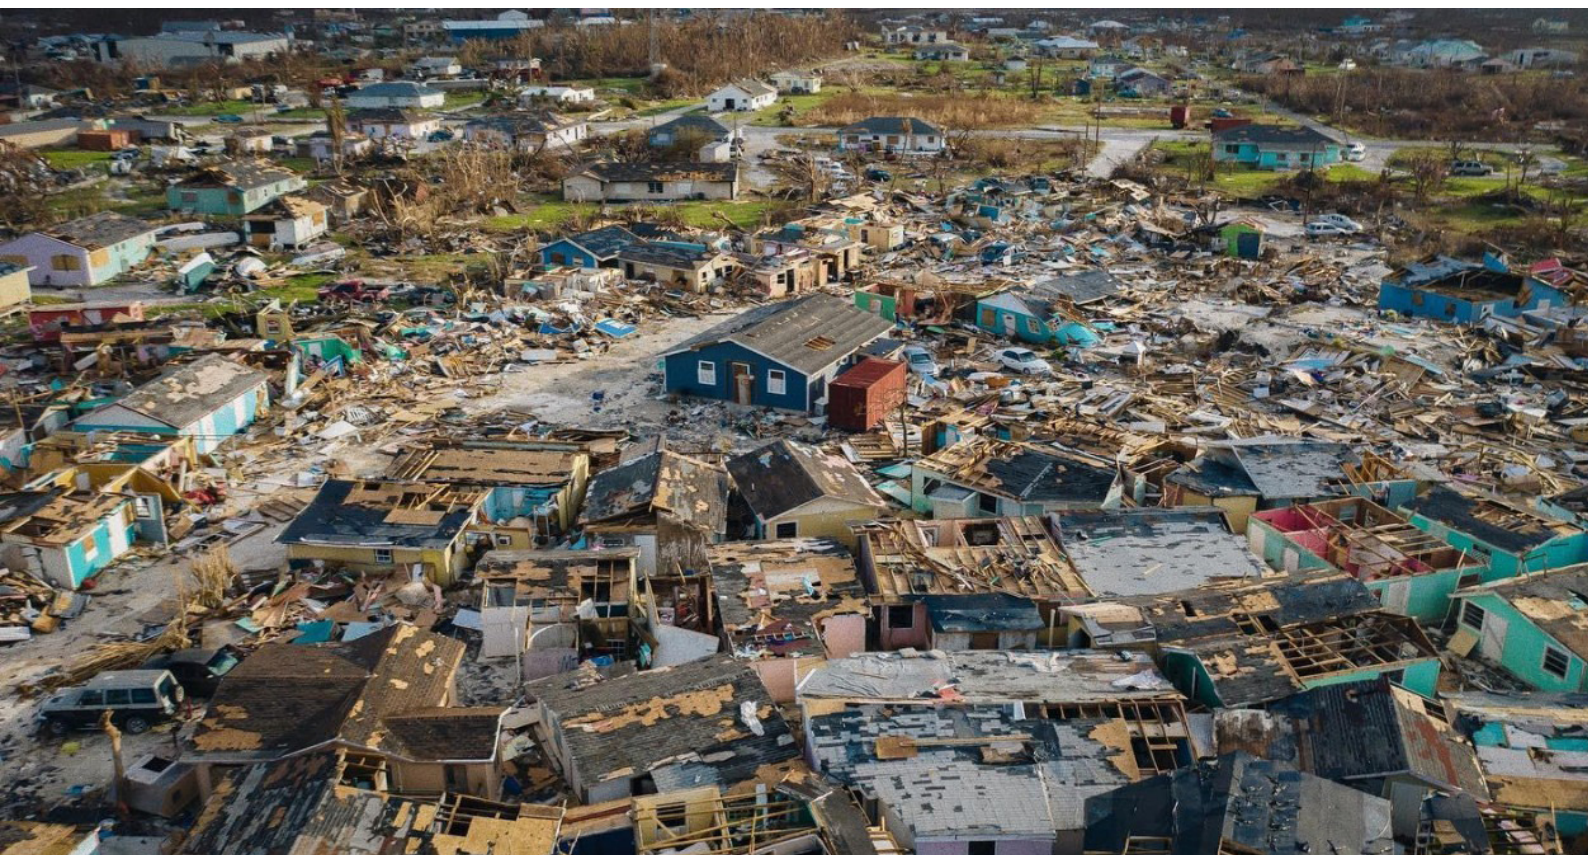
Housing damage caused by Hurricane Dorian on the island of Abaco, Bahamas, 2019, Source: IFRC

In areas that suffered high wind damage only, typically there was significant roof damage; however, some structures suffered total destruction. In areas that suffered both wind and tidal surge, there was often widespread destruction. Many timber-framed structures which had suffered past flooding and went into the hurricane already weakened were particularly vulnerable.

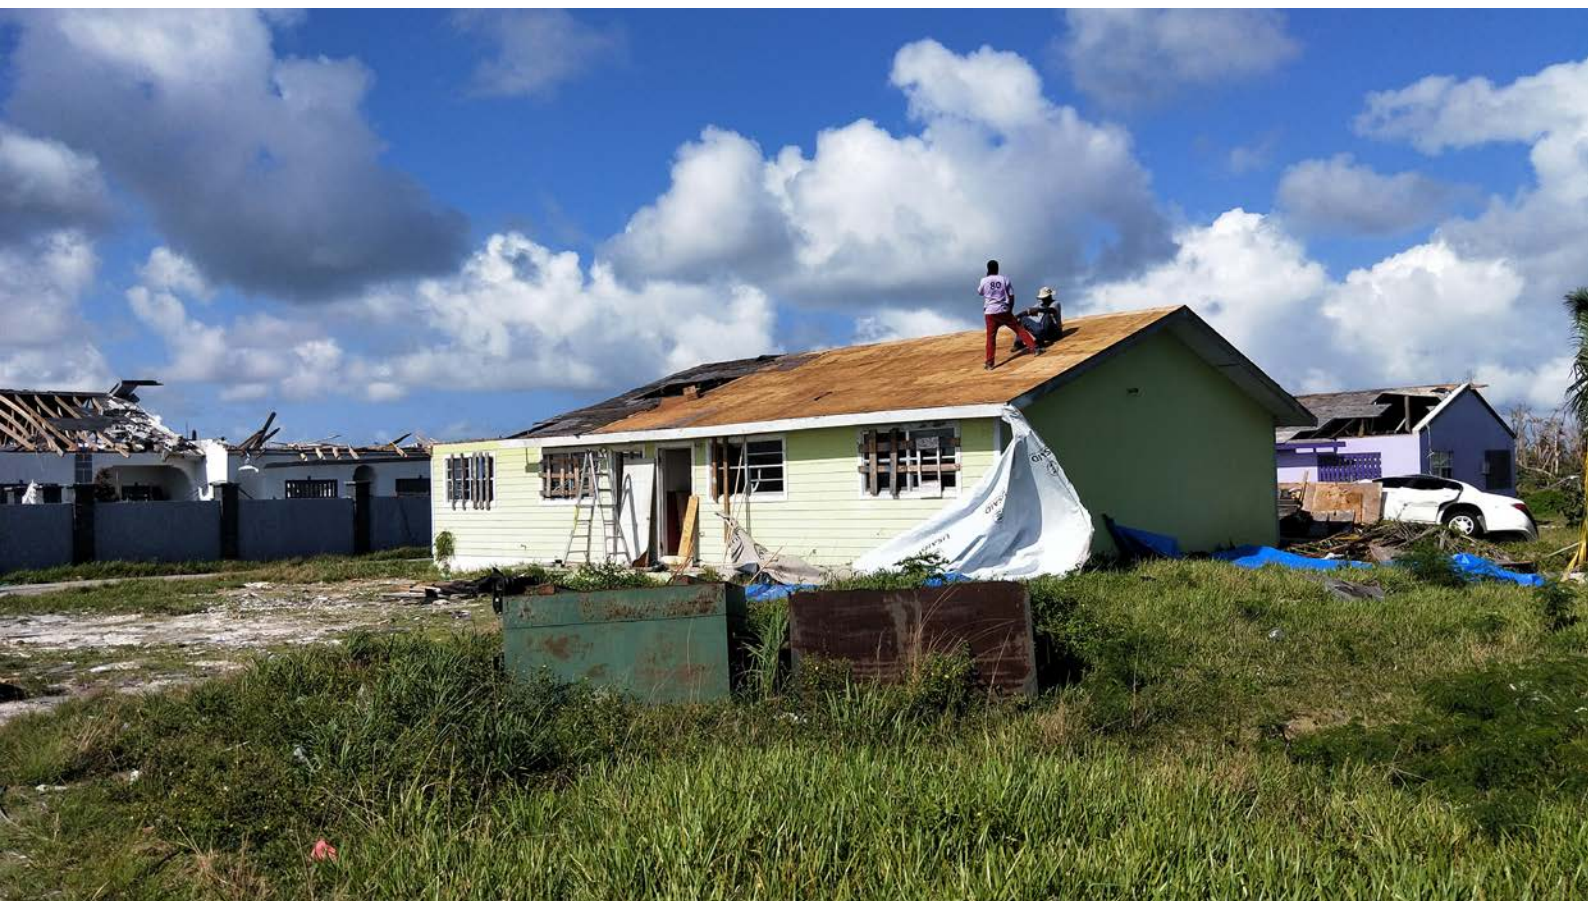
Completing roofing in Abaco (Source: BRCS/IFRC)

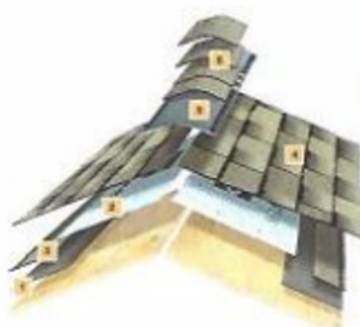
Package A: Exterior Repairs

1. Repair damaged roofing sub-structure (rafters, joists, wall plates, hurricane straps)
2. Repair/replace damaged plywood and install new underlayment.
3. Recondition septic tank/pit and incidentals to ensure uninterrupted flow of septage.
4. Repair and/or replace all exterior doors and all windows.
5. Install roof cover (shingles or metal sheets) and drip edges

- 1 Leak barrier/plywood
- 2 Underlayment (peel & stick)
- 3 Starter strip shingles
- 4 Shingles
- 5 Attic Vent (if applicable)
- 6 Ridge cap shingles
